### SUPPLEMENT C: Sedimentation Discussion Pictures

**SUPPLEMENT D: Erosion Discussion Pictures**

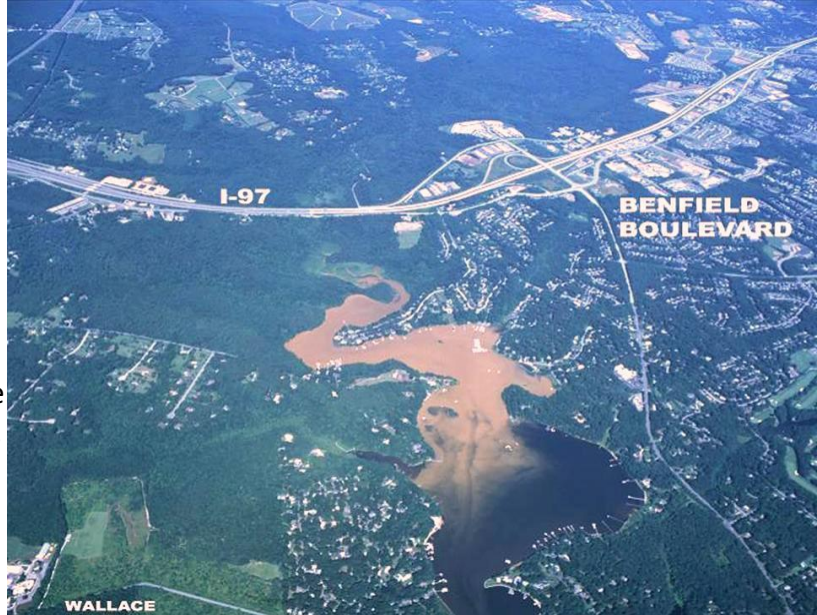
Severn River Photo:

This is an image of sediment in the Sever River. A construction site neglected to put up its silt fence over the weekend. That weekend there was a heavy rainstorm. With nothing to hold the soil in place all of the loose dirt and clay washed down the hill into the Sever River. We are still feeling the effects today.

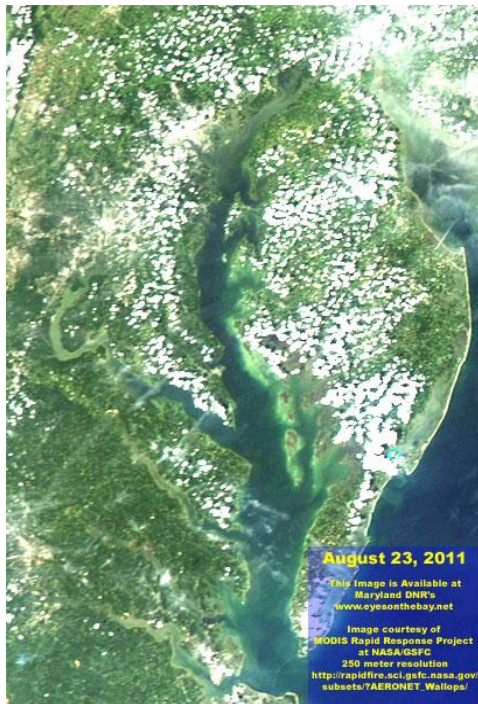
Photo A:

This is a satellite image of the Chesapeake Bay a few days before Hurricane Irene, which occurred on August 27, 2011.

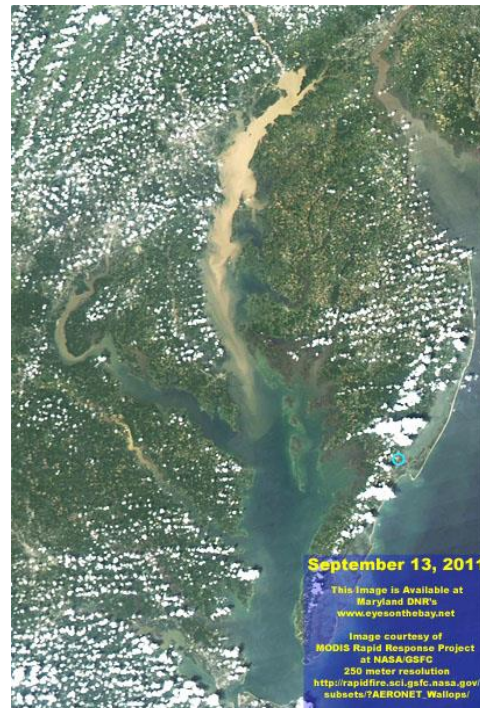
Photo B:

This is a satellite image of the Chesapeake Bay a few days AFTER hurricane Irene, which occurred on August 27, 2011. Note the sediment in the bay and its tributaries.

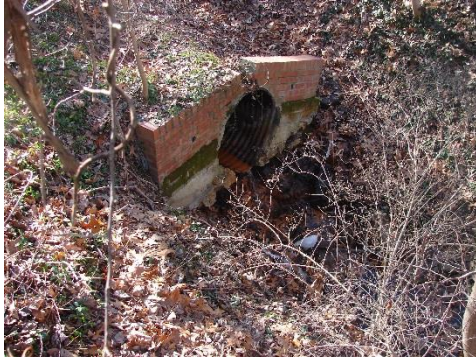
This is an outfall. Stormwater that goes into storm drains from the streets exits here. This is on Riva Road in Annapolis Maryland.

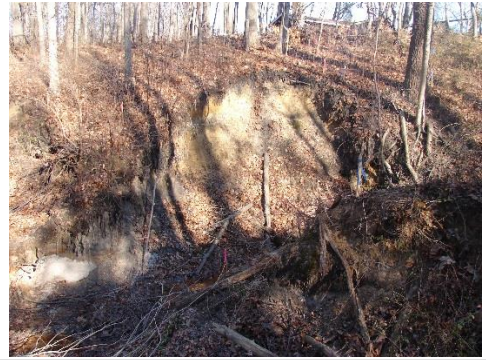
This is erosion caused by a poorly placed outfall. Nothing was planted near the outfall to slow down the water and let it soak in. After a major rain event, the water flows faster over the land and causes erosion.

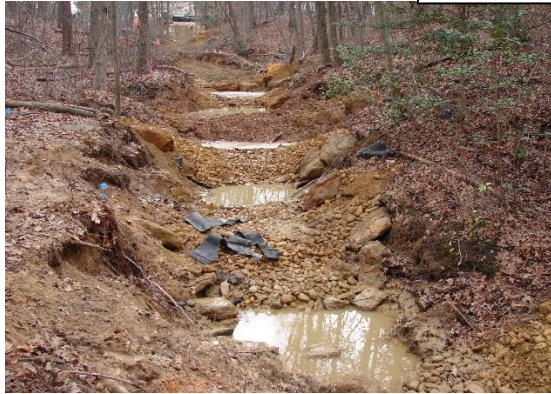
These are step pools. They are built to help slow down water and let it soak into the ground to prevent erosion.

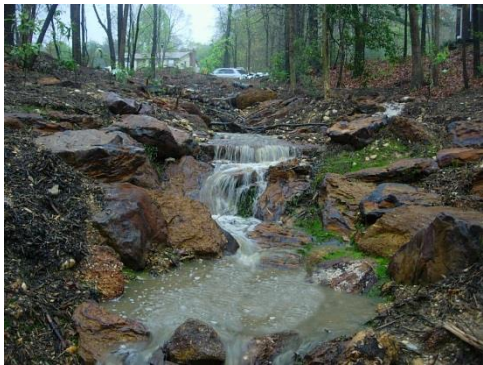
These are the step pools during a heavy rainstorm. Look at how the step pools allow the water to flow into pools where it can soak into the ground.

The step pools are made to look natural by adding native plants and rocks. Students from Anne Arundel County helped to plant plants around the site.
