Supplement A: Background Information

SUPPLEMENT B: Sedimentation Discussion Pictures

SUPPLEMENT C: Erosion Discussion Pictures

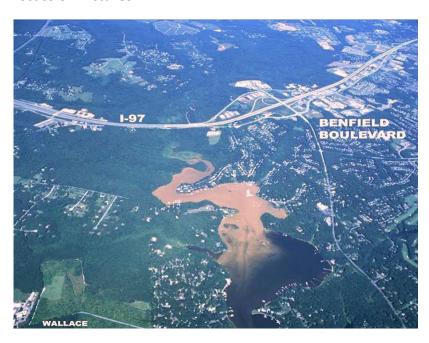
Severn River Photo:

This is an image of sediment in the Severn River. Several years ago, a construction site neglected to put up its silt fence over the weekend. That weekend there was a heavy rainstorm. With nothing to hold the soil in place, all the loose dirt and clay washed down the hill into the Severn River. We are still feeling the effects today.

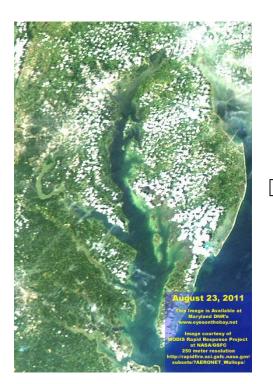
Photo A:

This is a satellite image of the Chesapeake Bay a few days before Hurricane Irene, which occurred on August, 27, 2011.

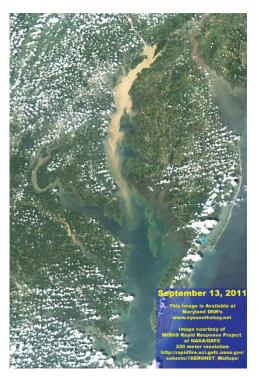
Photo B:

This is a satellite image of the Chesapeake Bay a few days AFTER hurricane Irene, which occurred on August 27, 2011. Note the sediment in the bay and its tributaries.
